Regency House Condominium Plaza Parking Garage Repairs

Phoenix, AZ

Submitted by Gervasio & Associates, Inc.

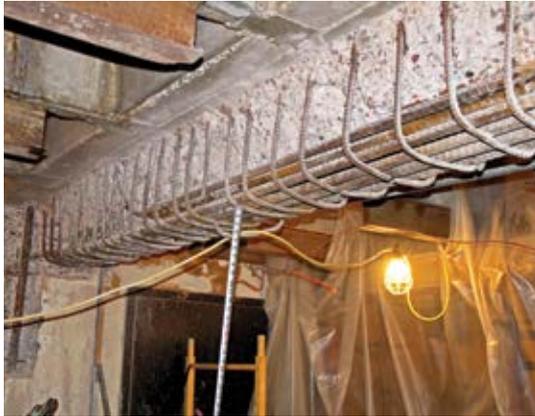
The start of concrete repairs to a beam. Note how ties on the right side are all broken from the expansive pressure of corrosion of longitudinal bars

Moisture infiltration from planters and plaza areas occurred for years. Metal "drip pans" had been erected in many areas to catch dripping water and prevent damage to cars. Removal of the drip pans revealed widespread corrosion and spalling, resulting in emergency shoring.

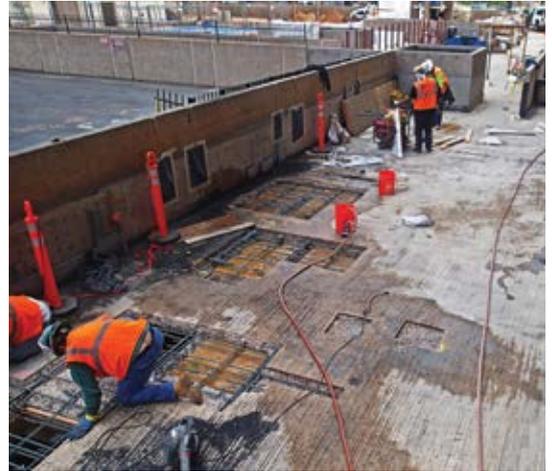
Full- and partial-depth repairs on slab in planter area

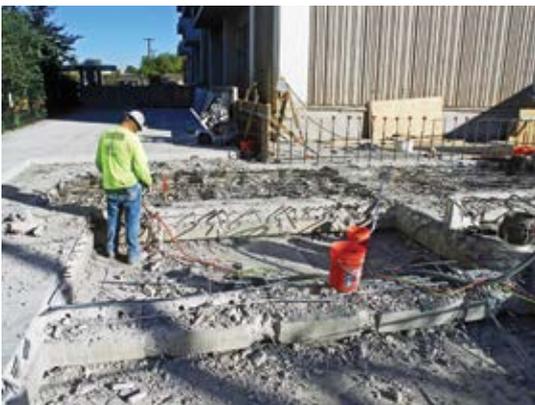
Thru-deck repairs: The largest unanticipated concrete repair was in the front street level parking area, which had concrete topping over a waterproof membrane over a structural pan deck floor joist system. In some areas, the bottom side of the structural slab showed significant signs of moisture

Complete removal and replacement of a portion of floor slab in front of building

intrusion. Those areas were identified for complete removal and replacement. However, after the topping/waterproofing was removed, significant additional deterioration was discovered at top reinforcing bars of slabs and beams. Because portions of the slab had to remain available for on-site parking, the topping for the full parking area could not be completely removed. The full magnitude of this problem remained unknown until final repairs were exposed.

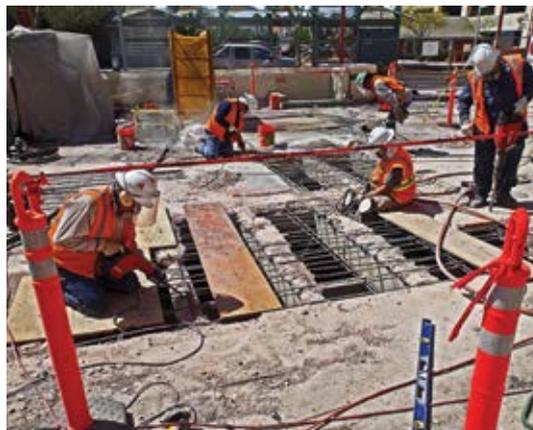
Removal of concrete topping in front parking lot

Incorrect topping slab thickness: Concrete topping in the front parking area was indicated on the original construction drawings to be 2 in. (51 mm) maximum thickness. Circa 1980s, a new waterproof membrane was installed, requiring topping replacement. To provide storm-water drainage, this new topping was sloped by increasing depth. During design, coring revealed actual topping thicknesses two to six times the original design thickness, significantly overloading the structure.

The solution was to use high-density foam in lieu of concrete between the waterproofing and topping, which reduced structural loading, provided proper slope for drainage by tapering the foam, and eliminated costs of reinforcing the structure.

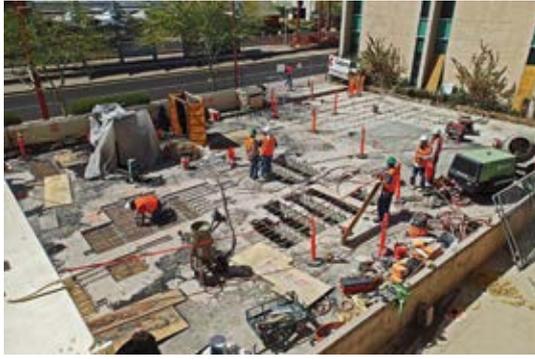
Looking down at front parking lot repairs

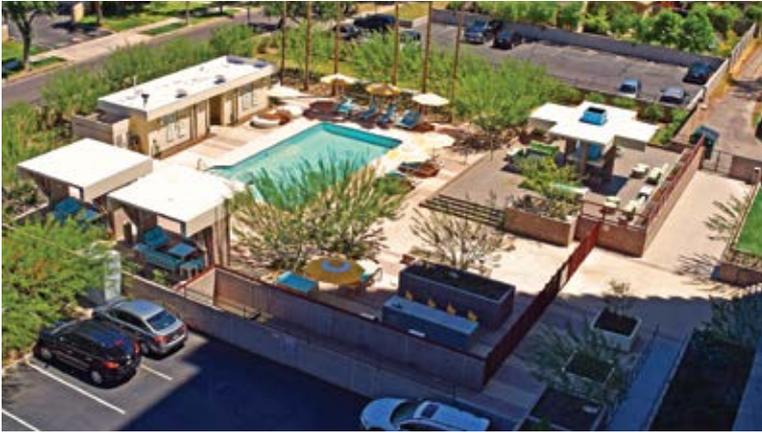
Back patio plaza area after renovation
