FINALIST - 2017 PROJECT OF THE YEAR

SPECIAL PROJECTS CATEGORY

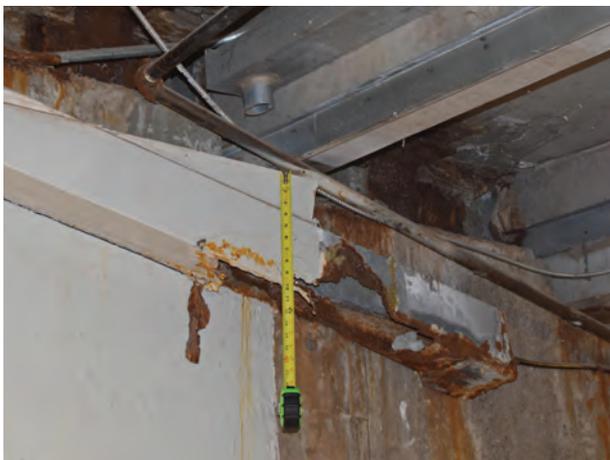
Fig. 2: Bottom side of seating riser at support—seating riser bearings and seismic restraint plates are visible on the bottom side. Moisture penetration through building expansion joint into mineral wool (each side of L-shaped plate) resulted in severe corrosion. Rain gutter system completely corroded through as it enters uninhabited space.

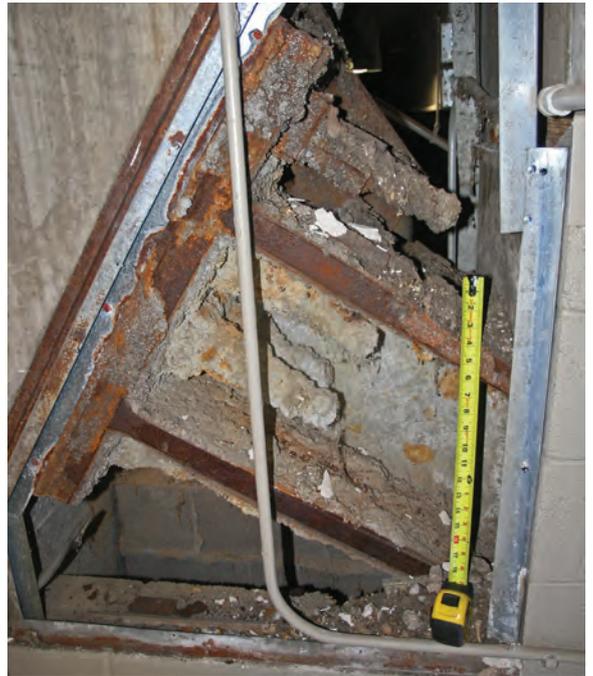
Fig. 3: Raker truss tieback anchor—connection between steel raker truss and concrete frame with sixteen 1-3/8" (35mm) diameter high strength threaded rebar anchor rods. Connection is completely hidden between two masonry walls in a dead space with leaking precast joint directly above. Spray-applied fireproofing absorbs water and never dries out.

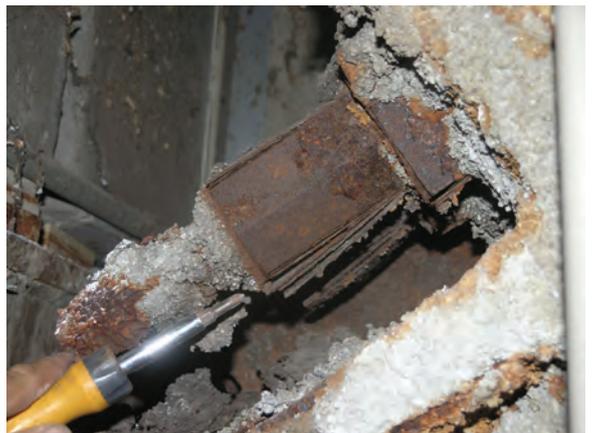
Fig. 4: Threaded rebar anchor nut—Severe deterioration of the nut. Corrosion of the threaded anchor rod is not visible due to fireproofing and debris.

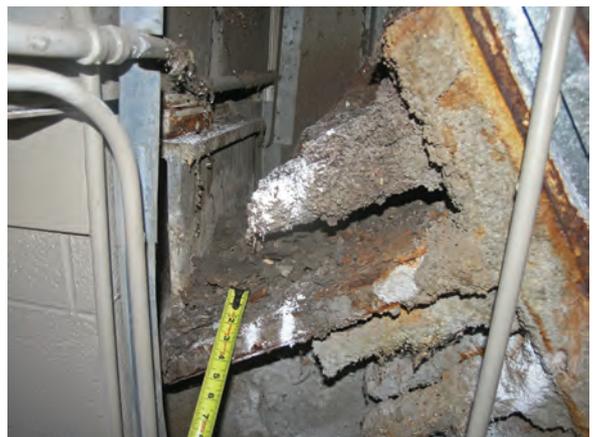
Fig. 5: Threaded rebar anchor—large mound at end of tape measure is peanut shells and debris washed through failed joint above.

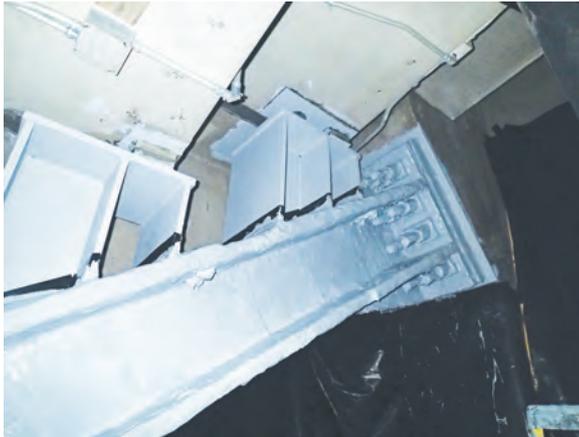
Fig. 6: Raker truss tieback anchor connection—completed repair with epoxy intumescent fireproofing to achieve 3-hour fire rating and provide corrosion protection to the beam and threaded rebar anchors.

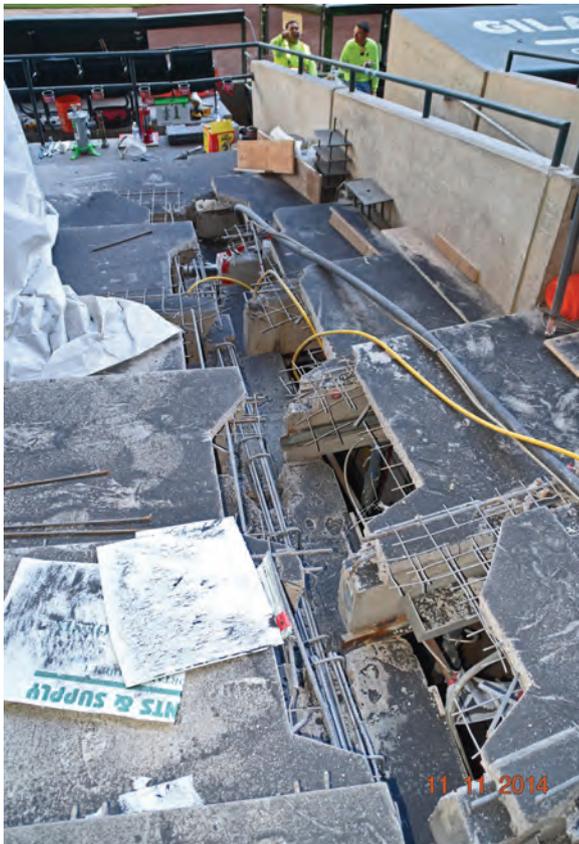
Fig. 7: Precast joint repairs—typical example of demolition required to repair the joints between the precast seating sections. Seismic restraint plates have been completely removed for replacement. Bearing repairs for stems have not started. Nearly every row was affected.

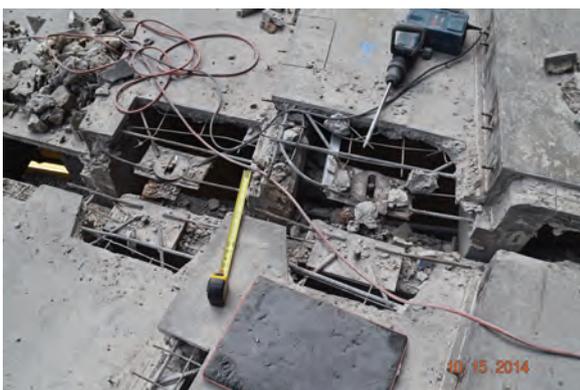
Fig. 8: Typical Precast Joint Repairs—Water leaking through building expansion joint between precast seating sections was absorbed by mineral wool fireproofing in the joint, resulting in severe deterioration. Large steel plates are seismic restraints.

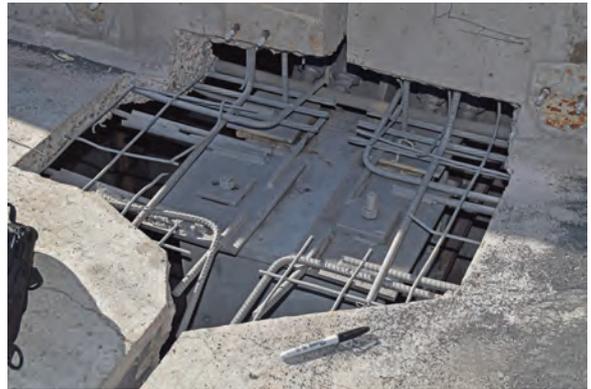
Fig. 9: Typical precast joint repairs—seismic restraint plate (embed with bolt) and precast bearing seat assembly (below prestressing strands) after existing plates replaced, rebar welded back, and sandblasted prior to epoxy coating and pour back.

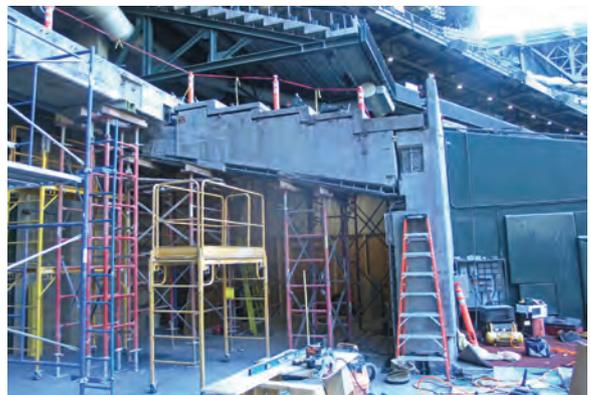
Fig. 10: Elephant Trunk Door Repairs—Water leaking between the door and precast resulted in severe corrosion, requiring emergency shoring during the baseball season.
