# ICRI 2009 Project Award Winner

## Award of Merit: Special Projects Category

### Arizona Veterans Memorial Coliseum Roof Repairs

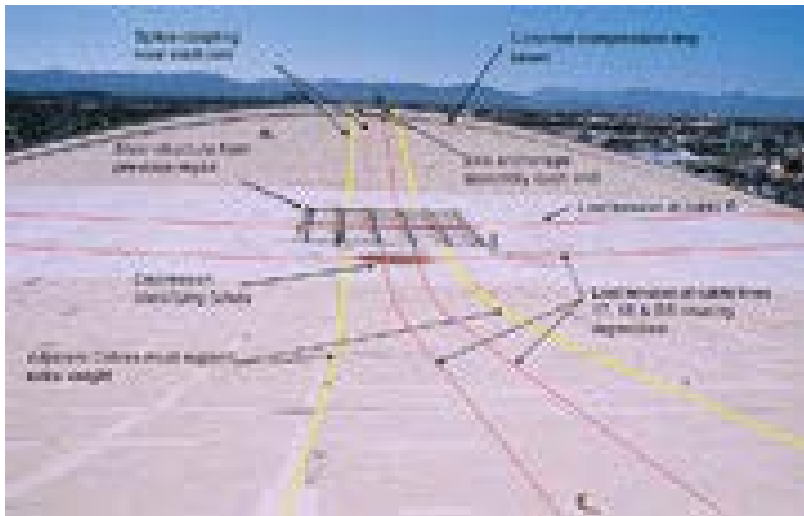
The Arizona Veterans Memorial Coliseum, constructed in 1964 as a premier arena facility at the Arizona State Fairgrounds, was home to the Phoenix Suns professional basketball team for 24 years. The roof is a cable structure in the shape of a hyperbolic paraboloid, designed by T.Y. Lin, and is one of the only remaining structures of its type. The roof cables span almost 400 ft (122 m), post-tensioned to 420,000 lb (190,509 kg) each, and support precast concrete roof panels between them.
